**An Investigation of the Corrosion Behaviour of a Range of  
Engineering Materials in Marine Environments**

**Vol. II**

**A Thesis**

**by Anne Neville**

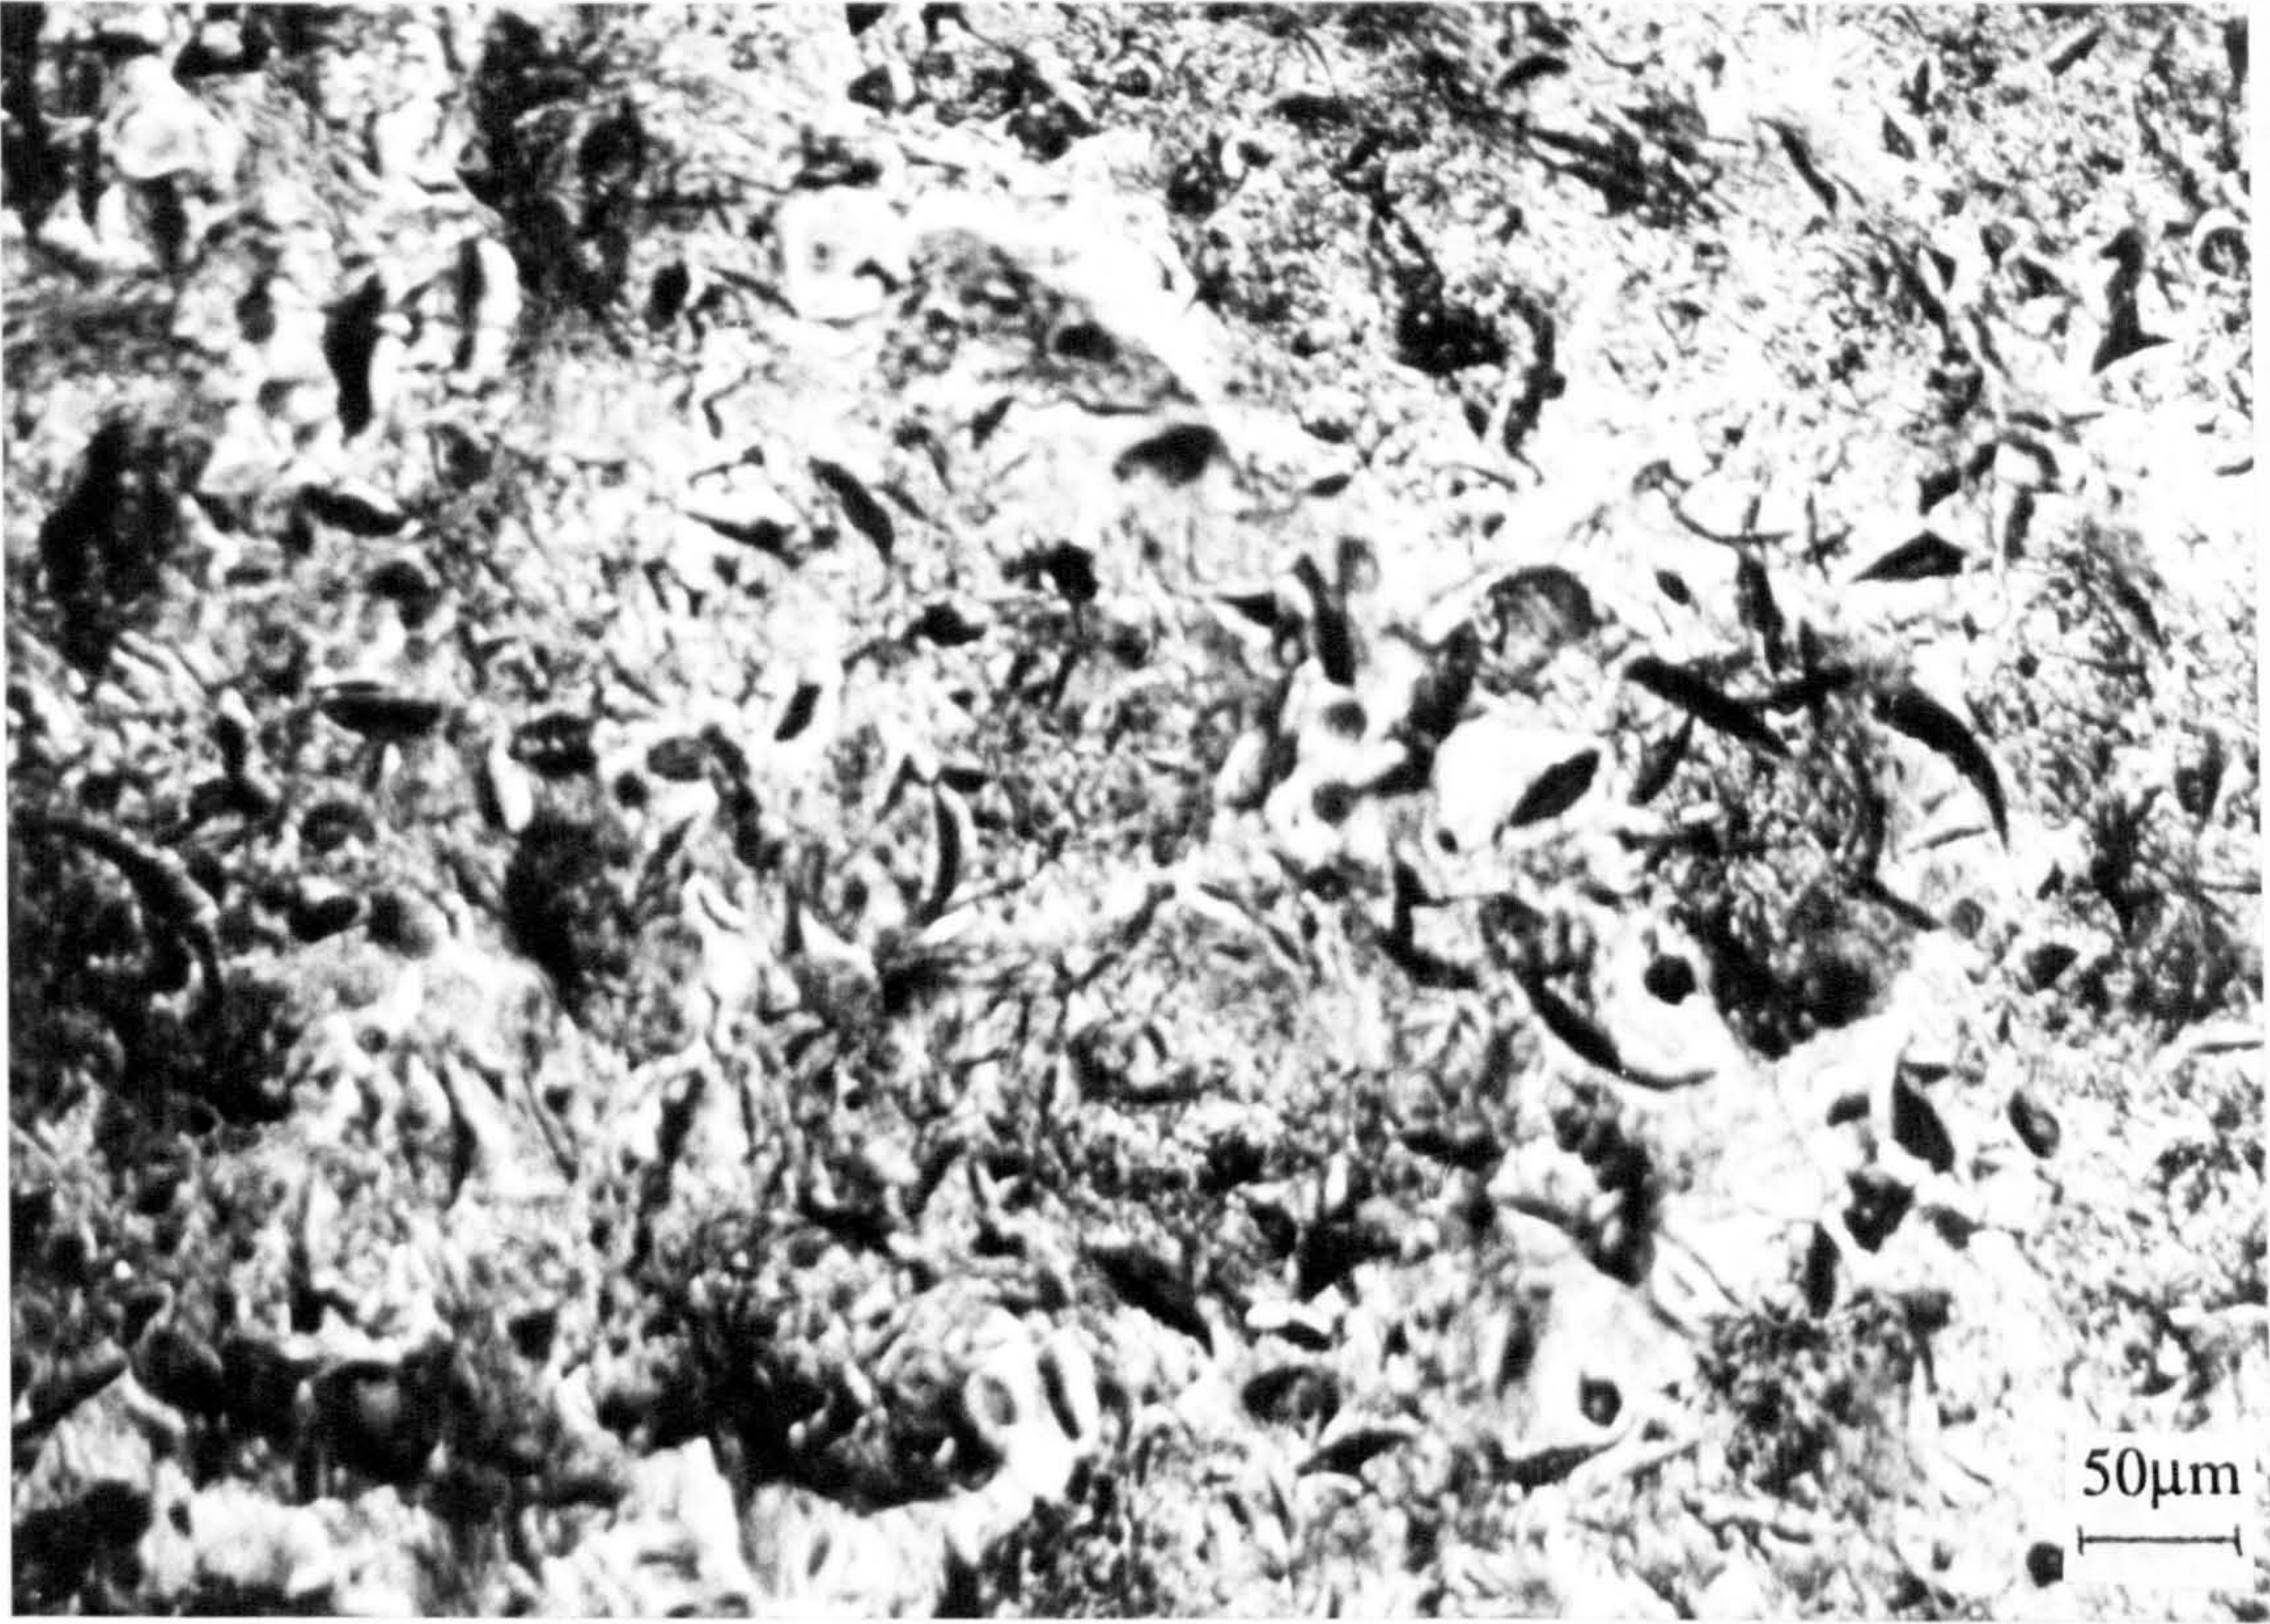
Fig. 6.6. As-produced steel then glass shot-peened surface

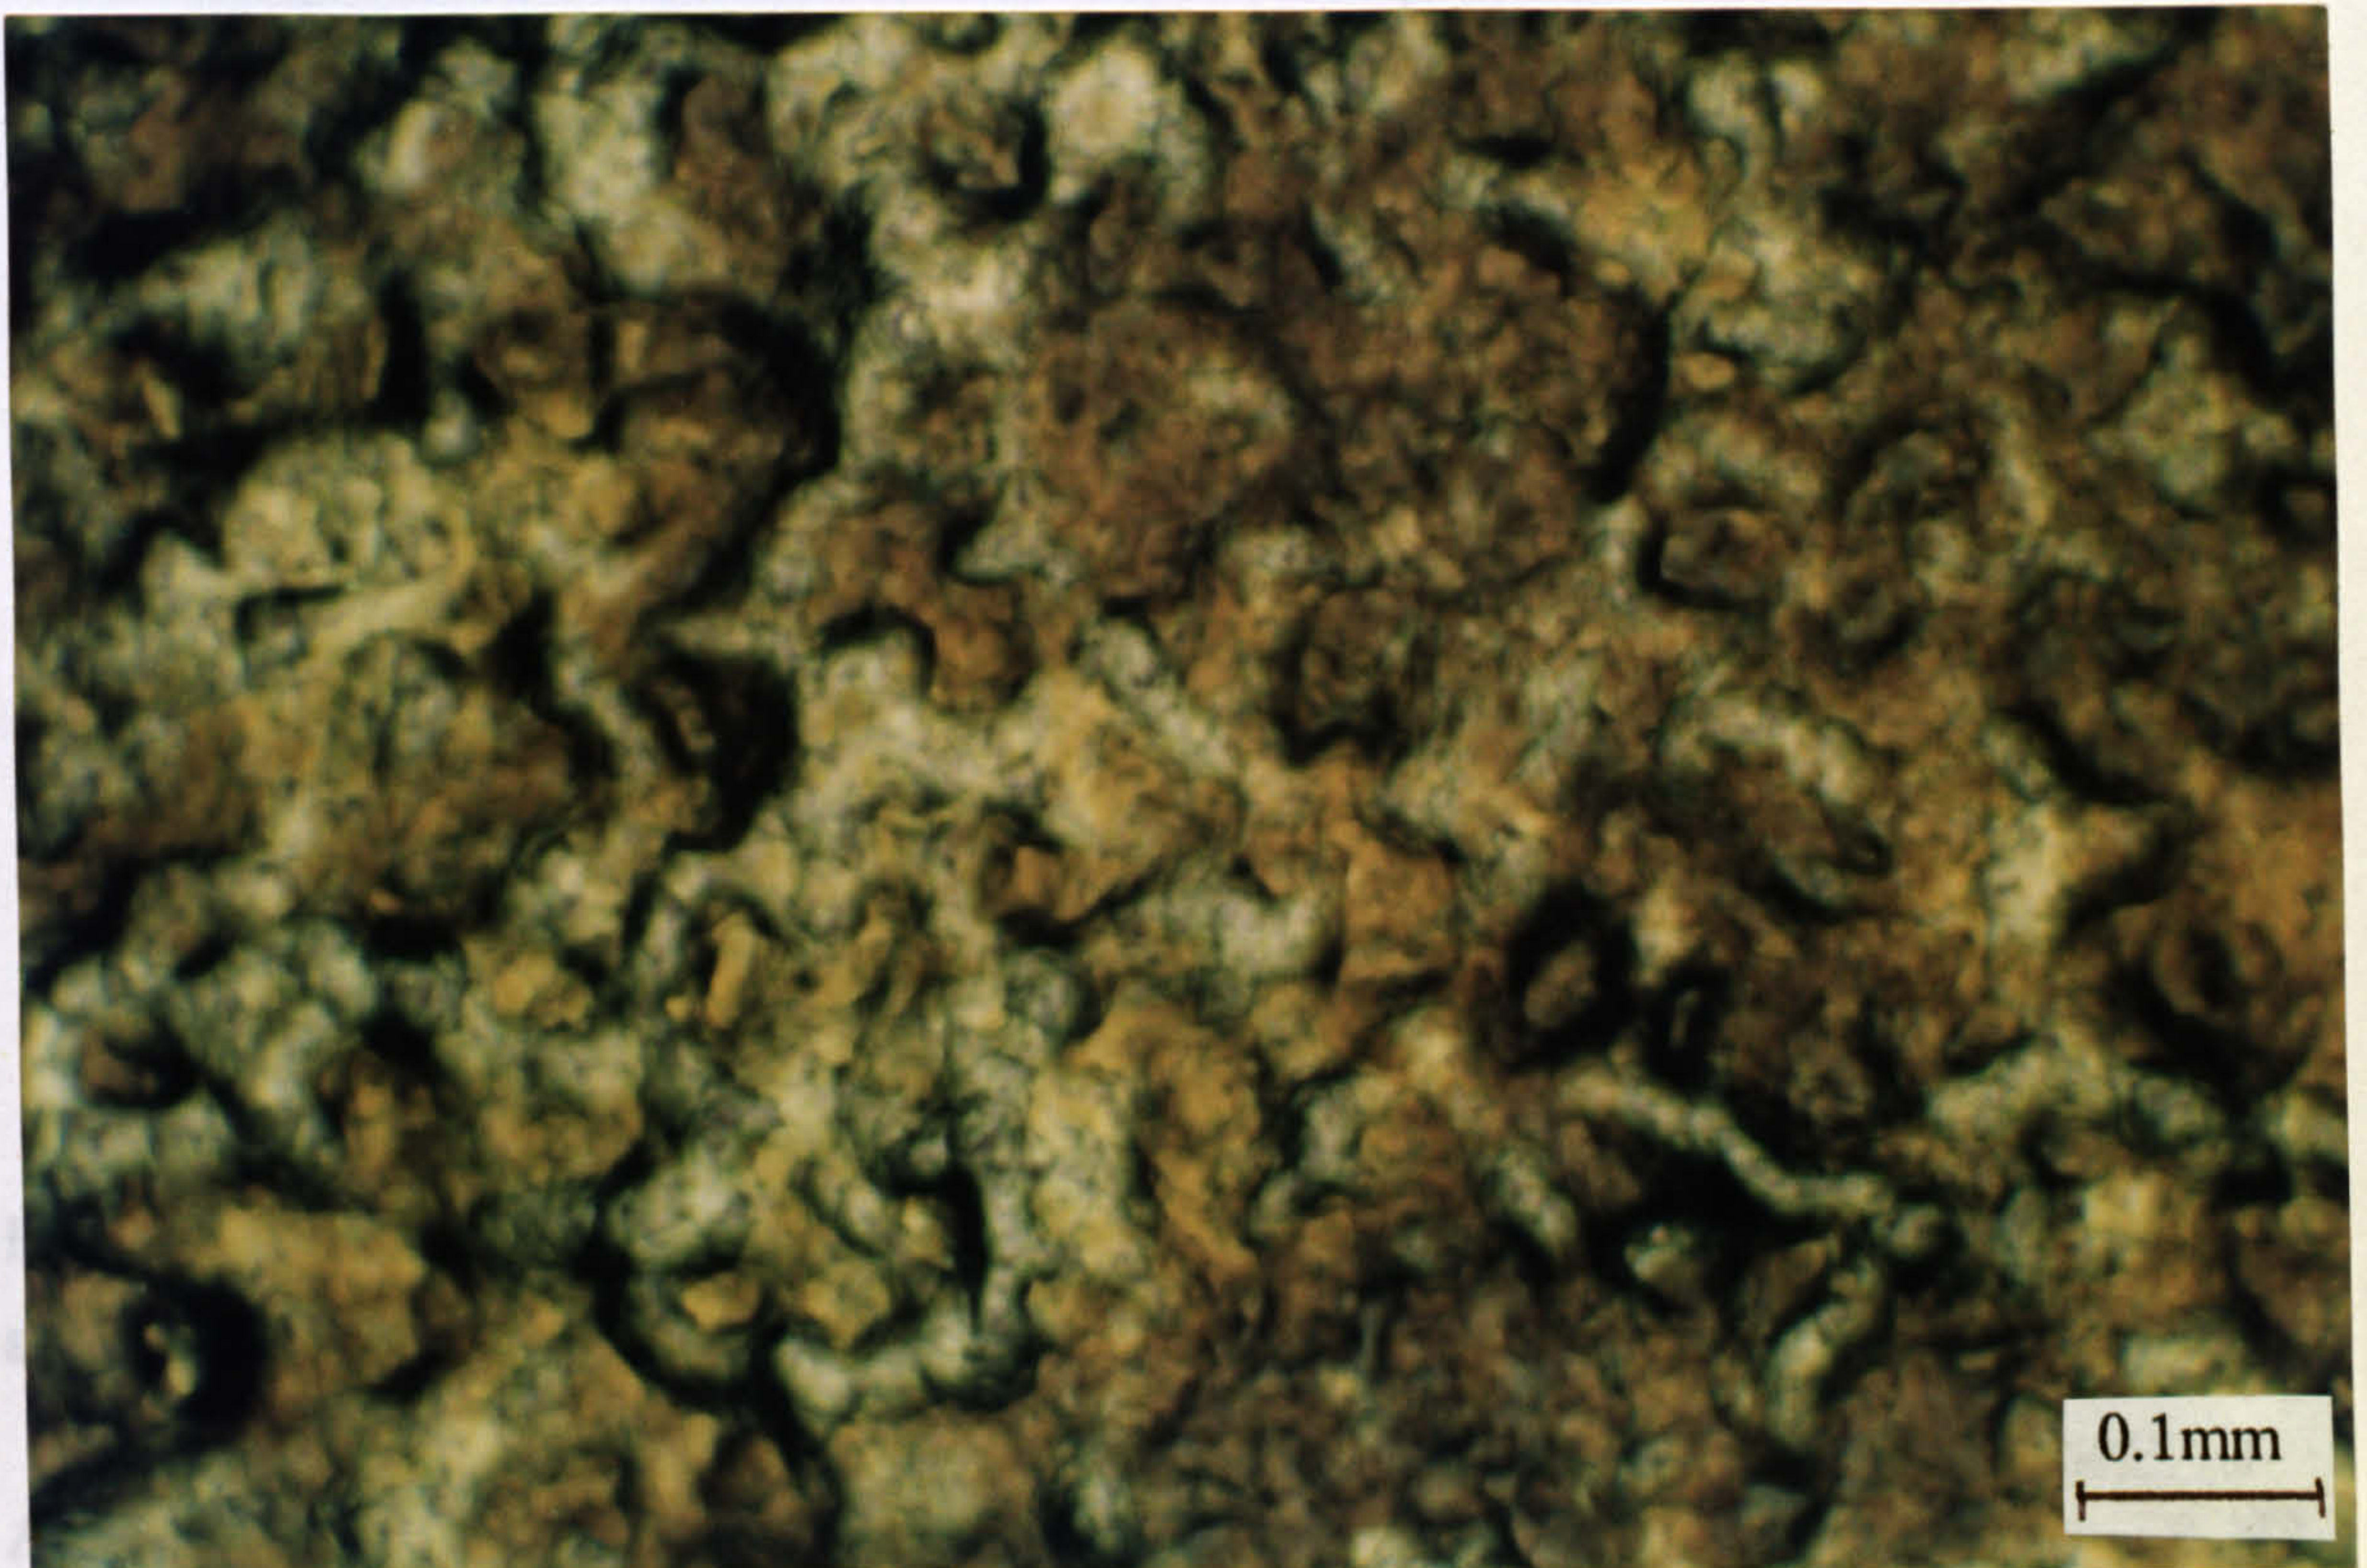
Fig. 6.21. Coloured film on UNS S31603 after anodic polarisation at 18°C under liquid impingement conditions.

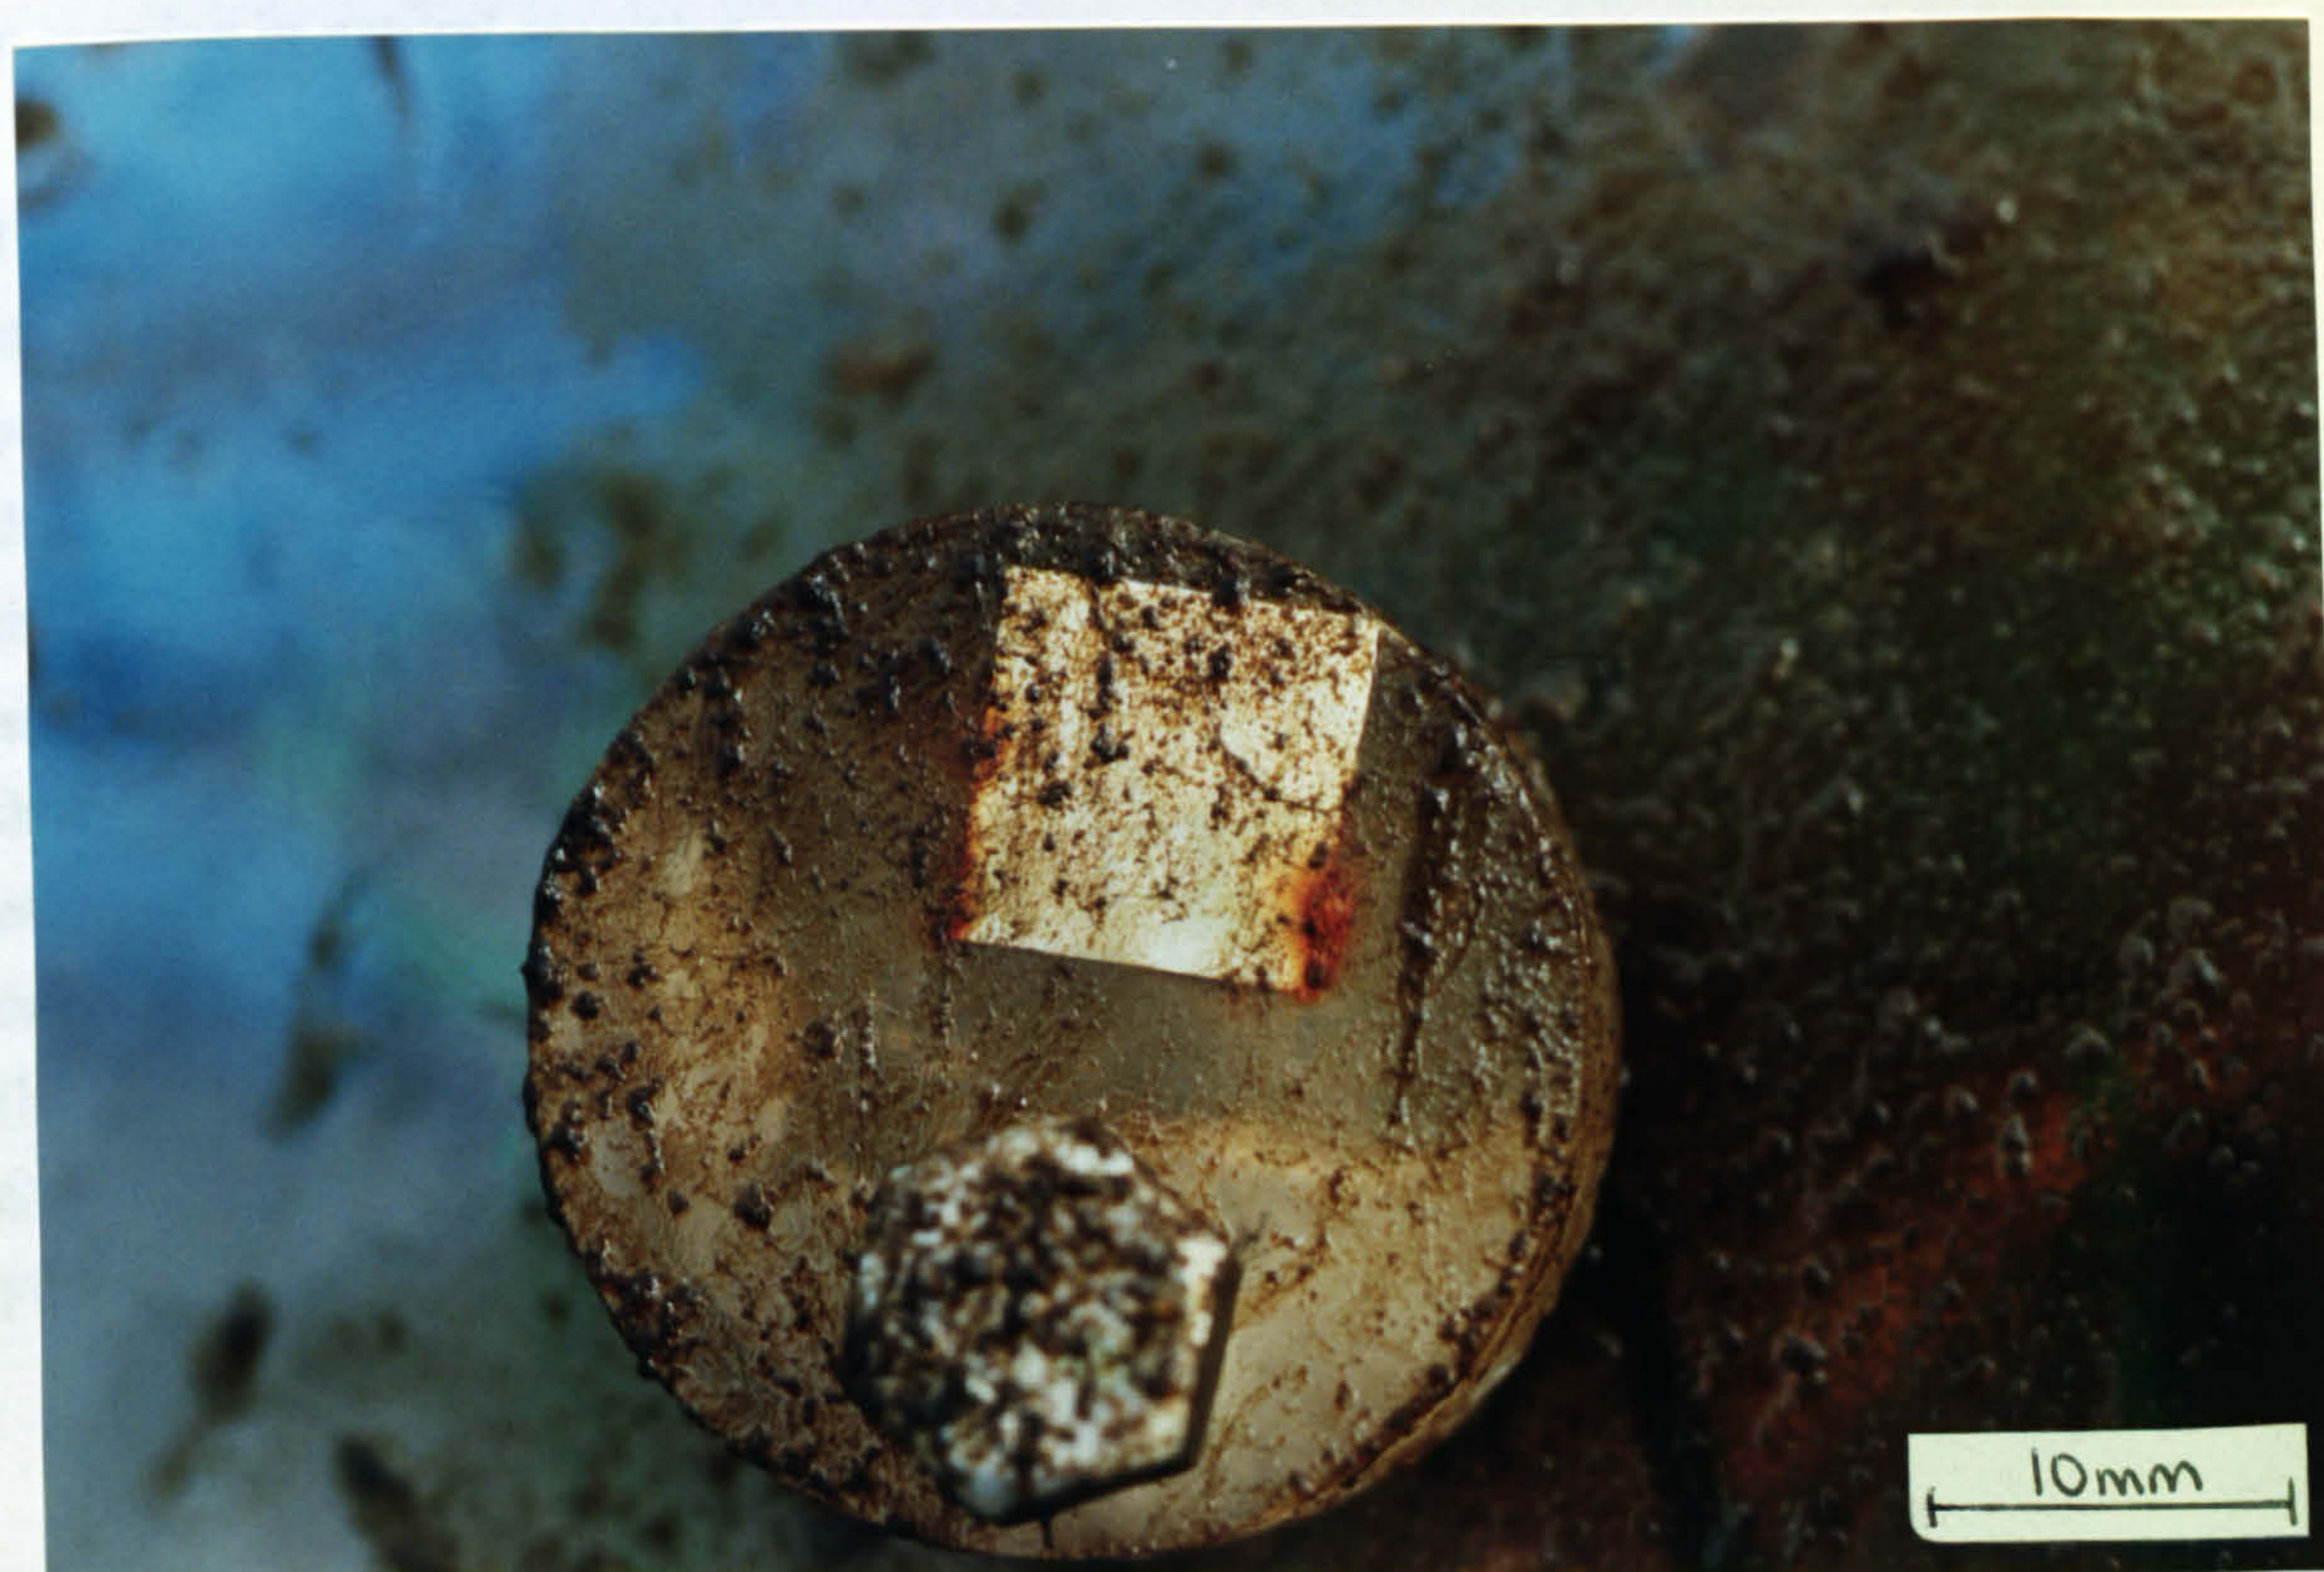
Fig. 8.41. Fouling over the UNS S31603 specimen after 119 days in natural seawater

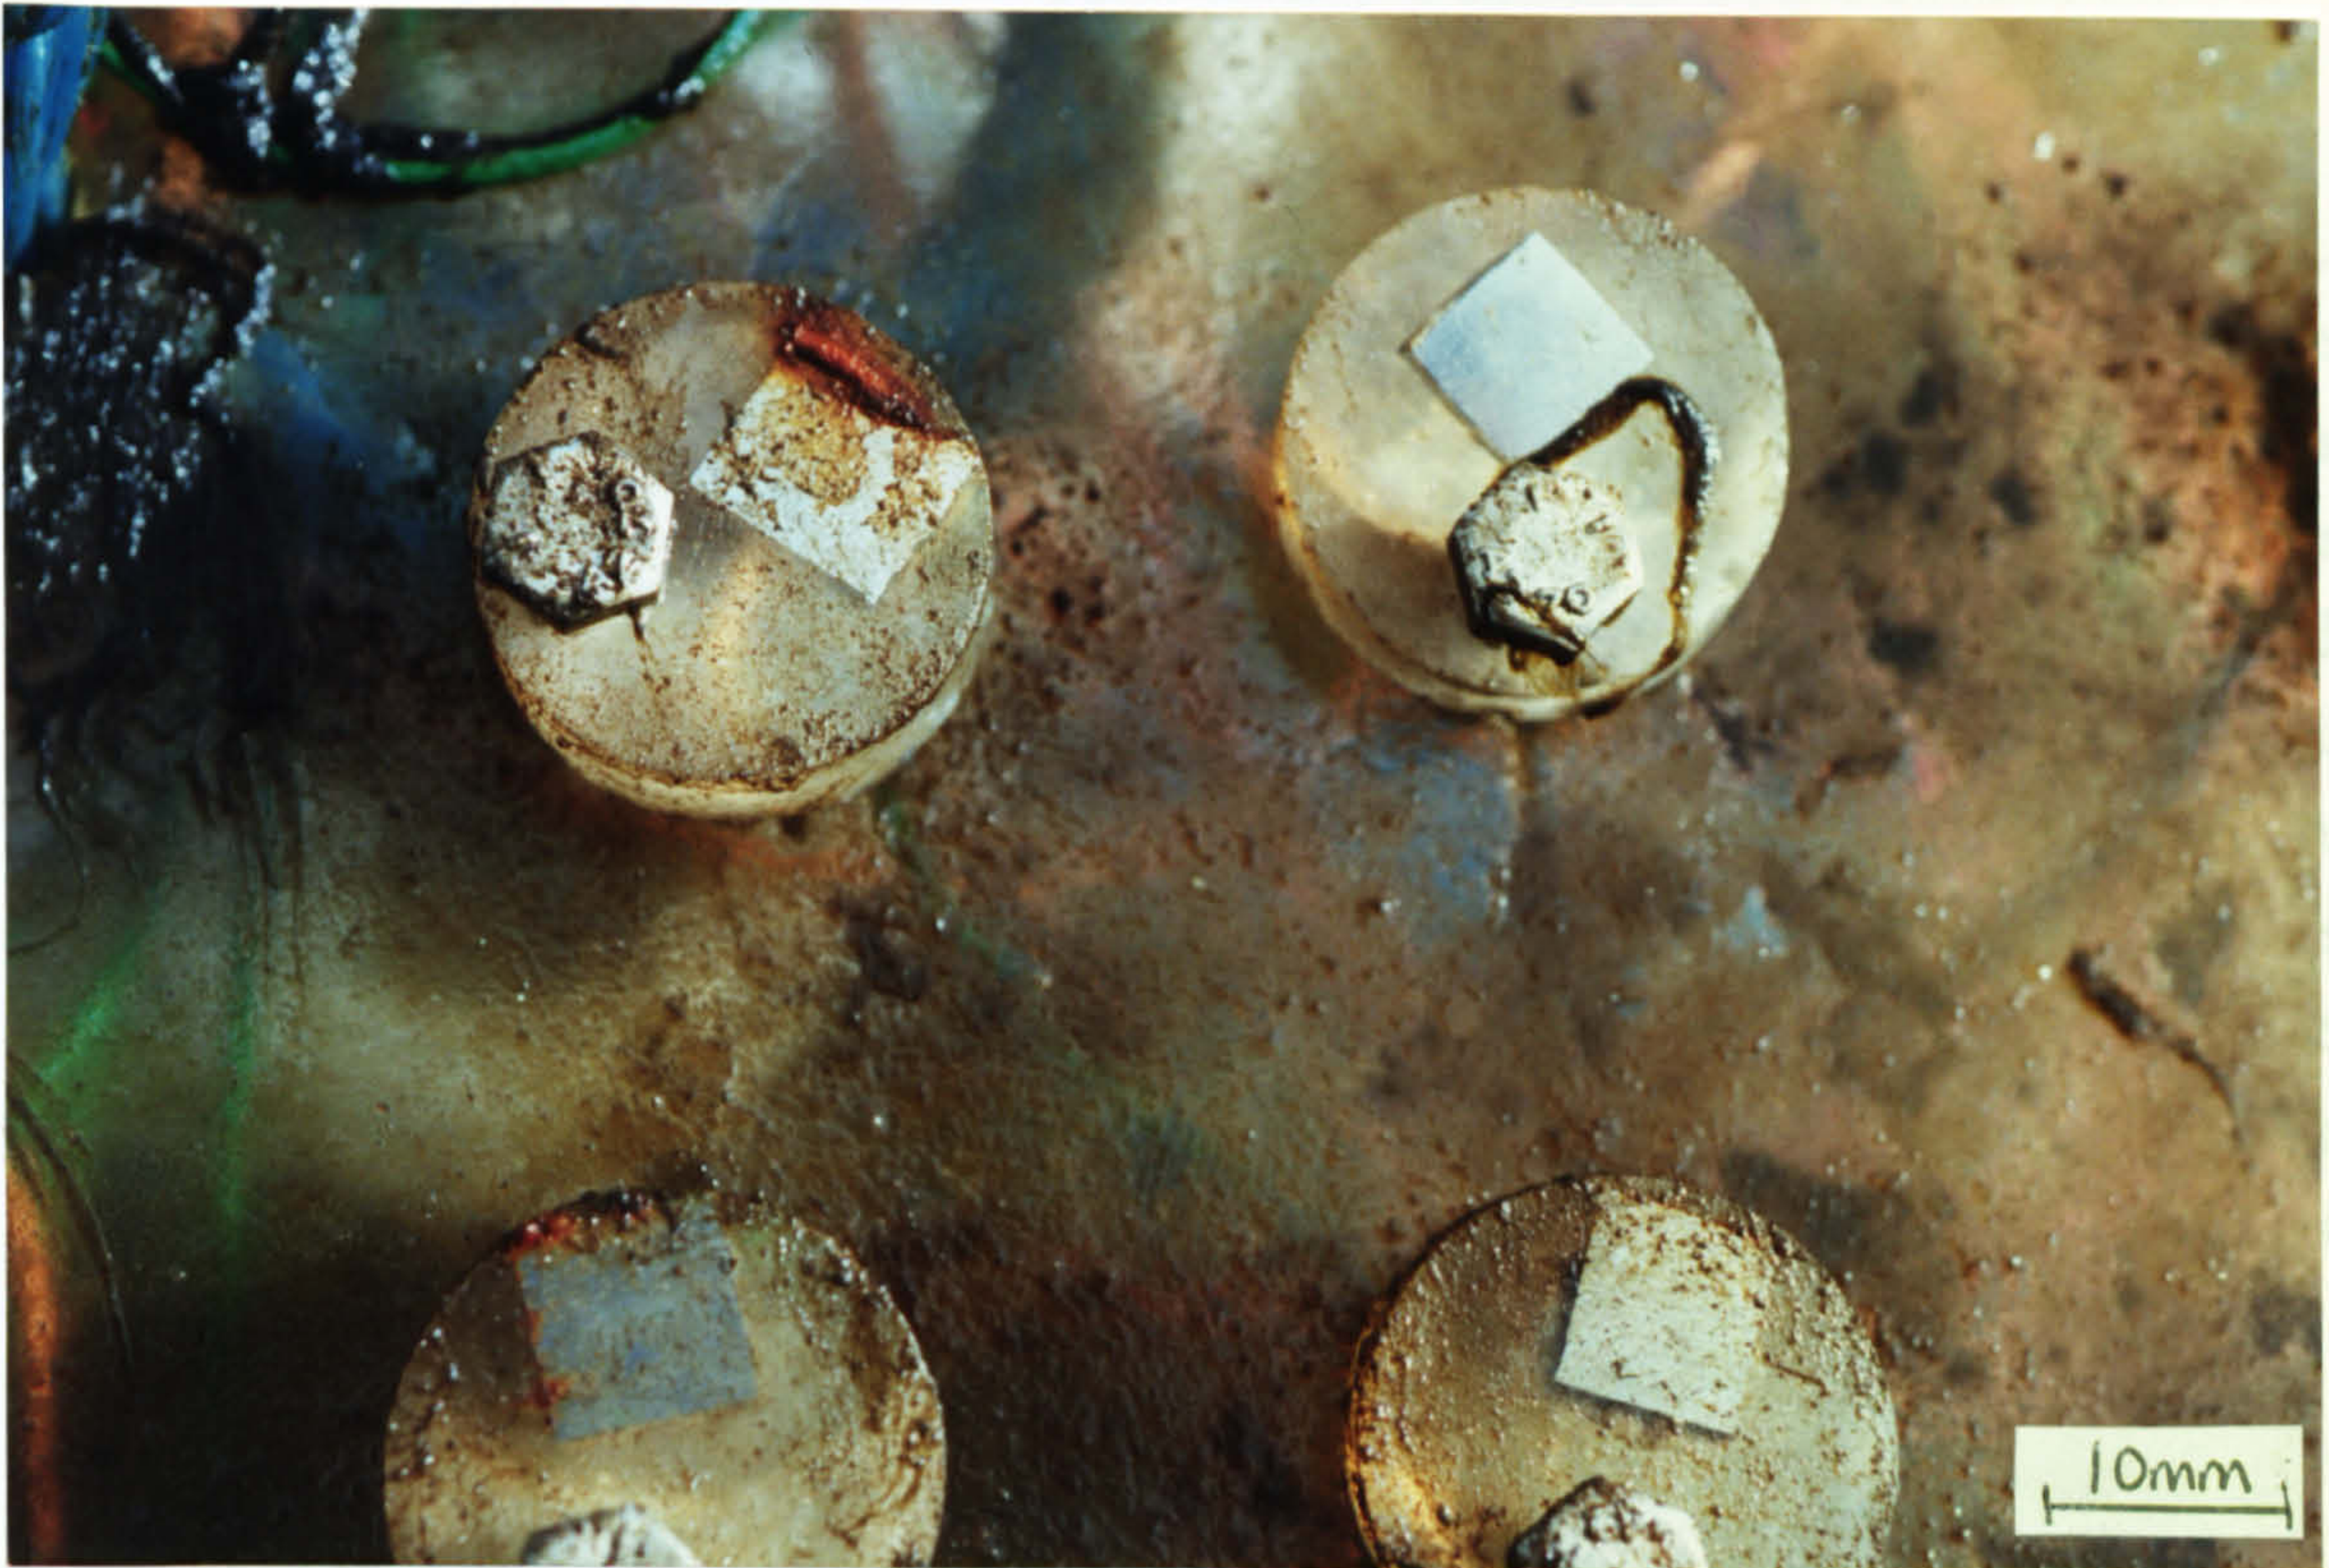
Fig. 8.44. Severe attack on SAF 2205 (left) with patchy fouling and in contrast, 2 of the 3 unattacked specimens of Inconel 625 (right). After 2 months in natural seawater at the free corrosion potential.

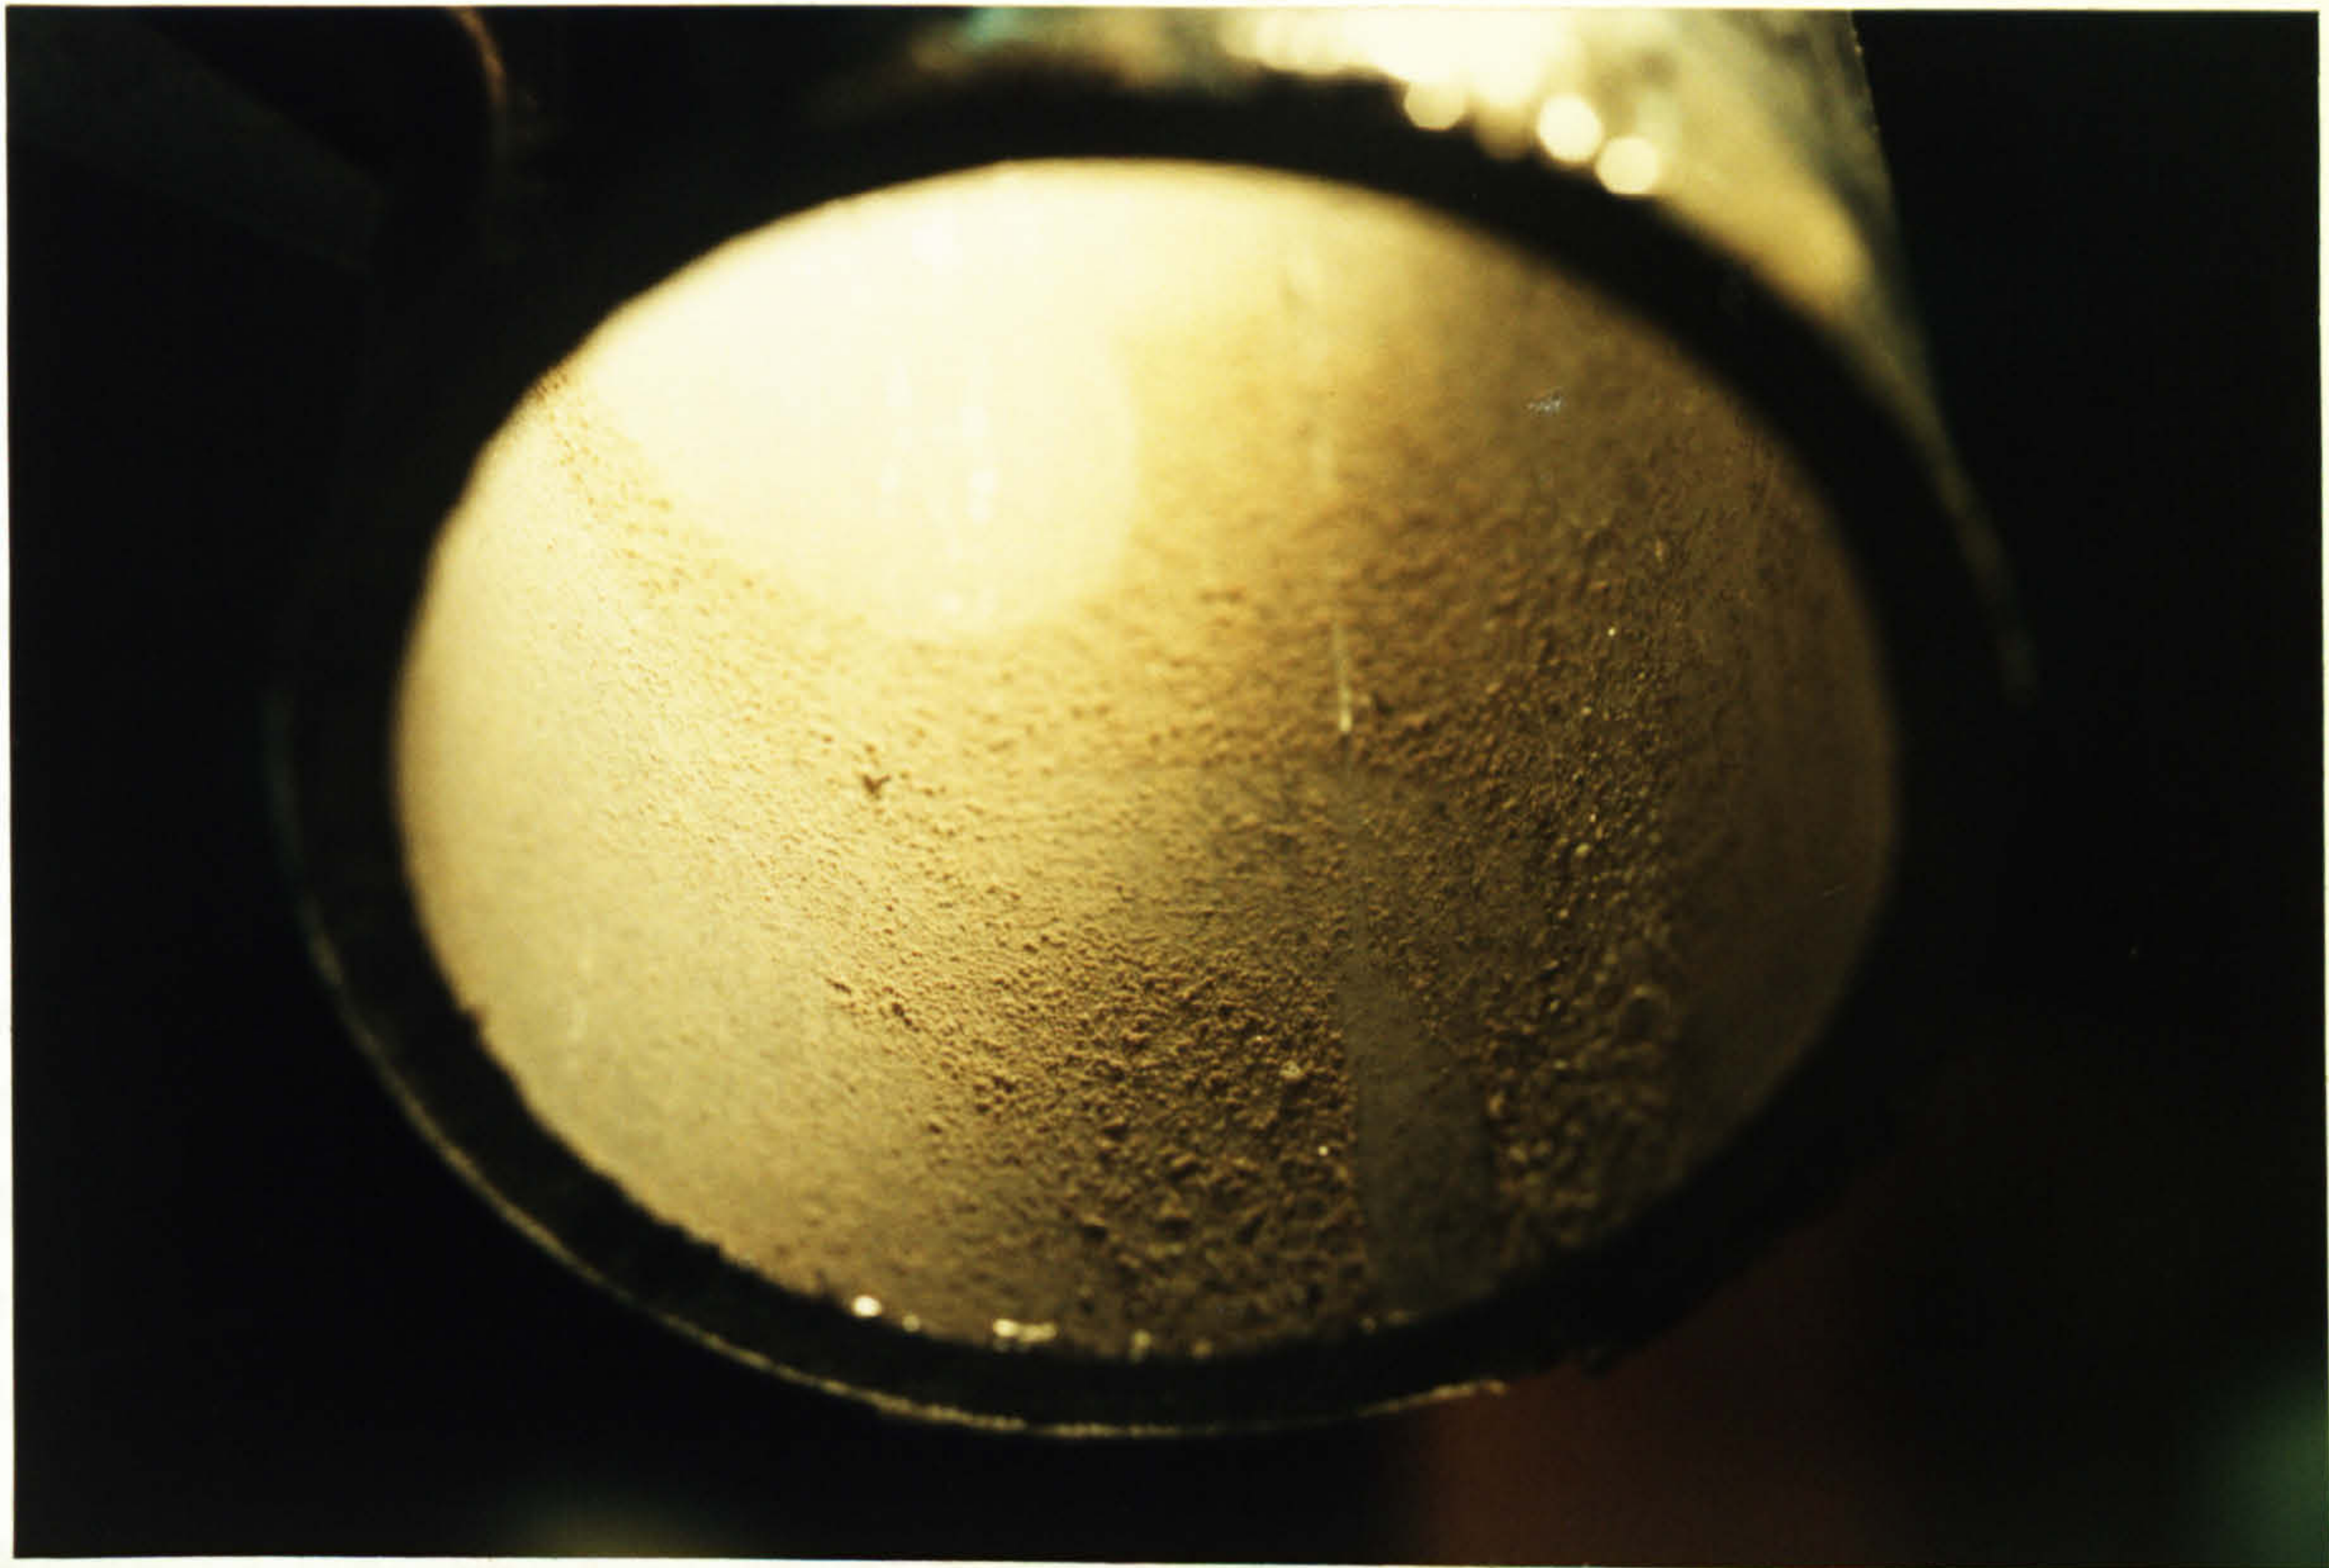
Fig. 9.13. Deposit on the inside of the welded pipe after 35 days in lower concentration flow

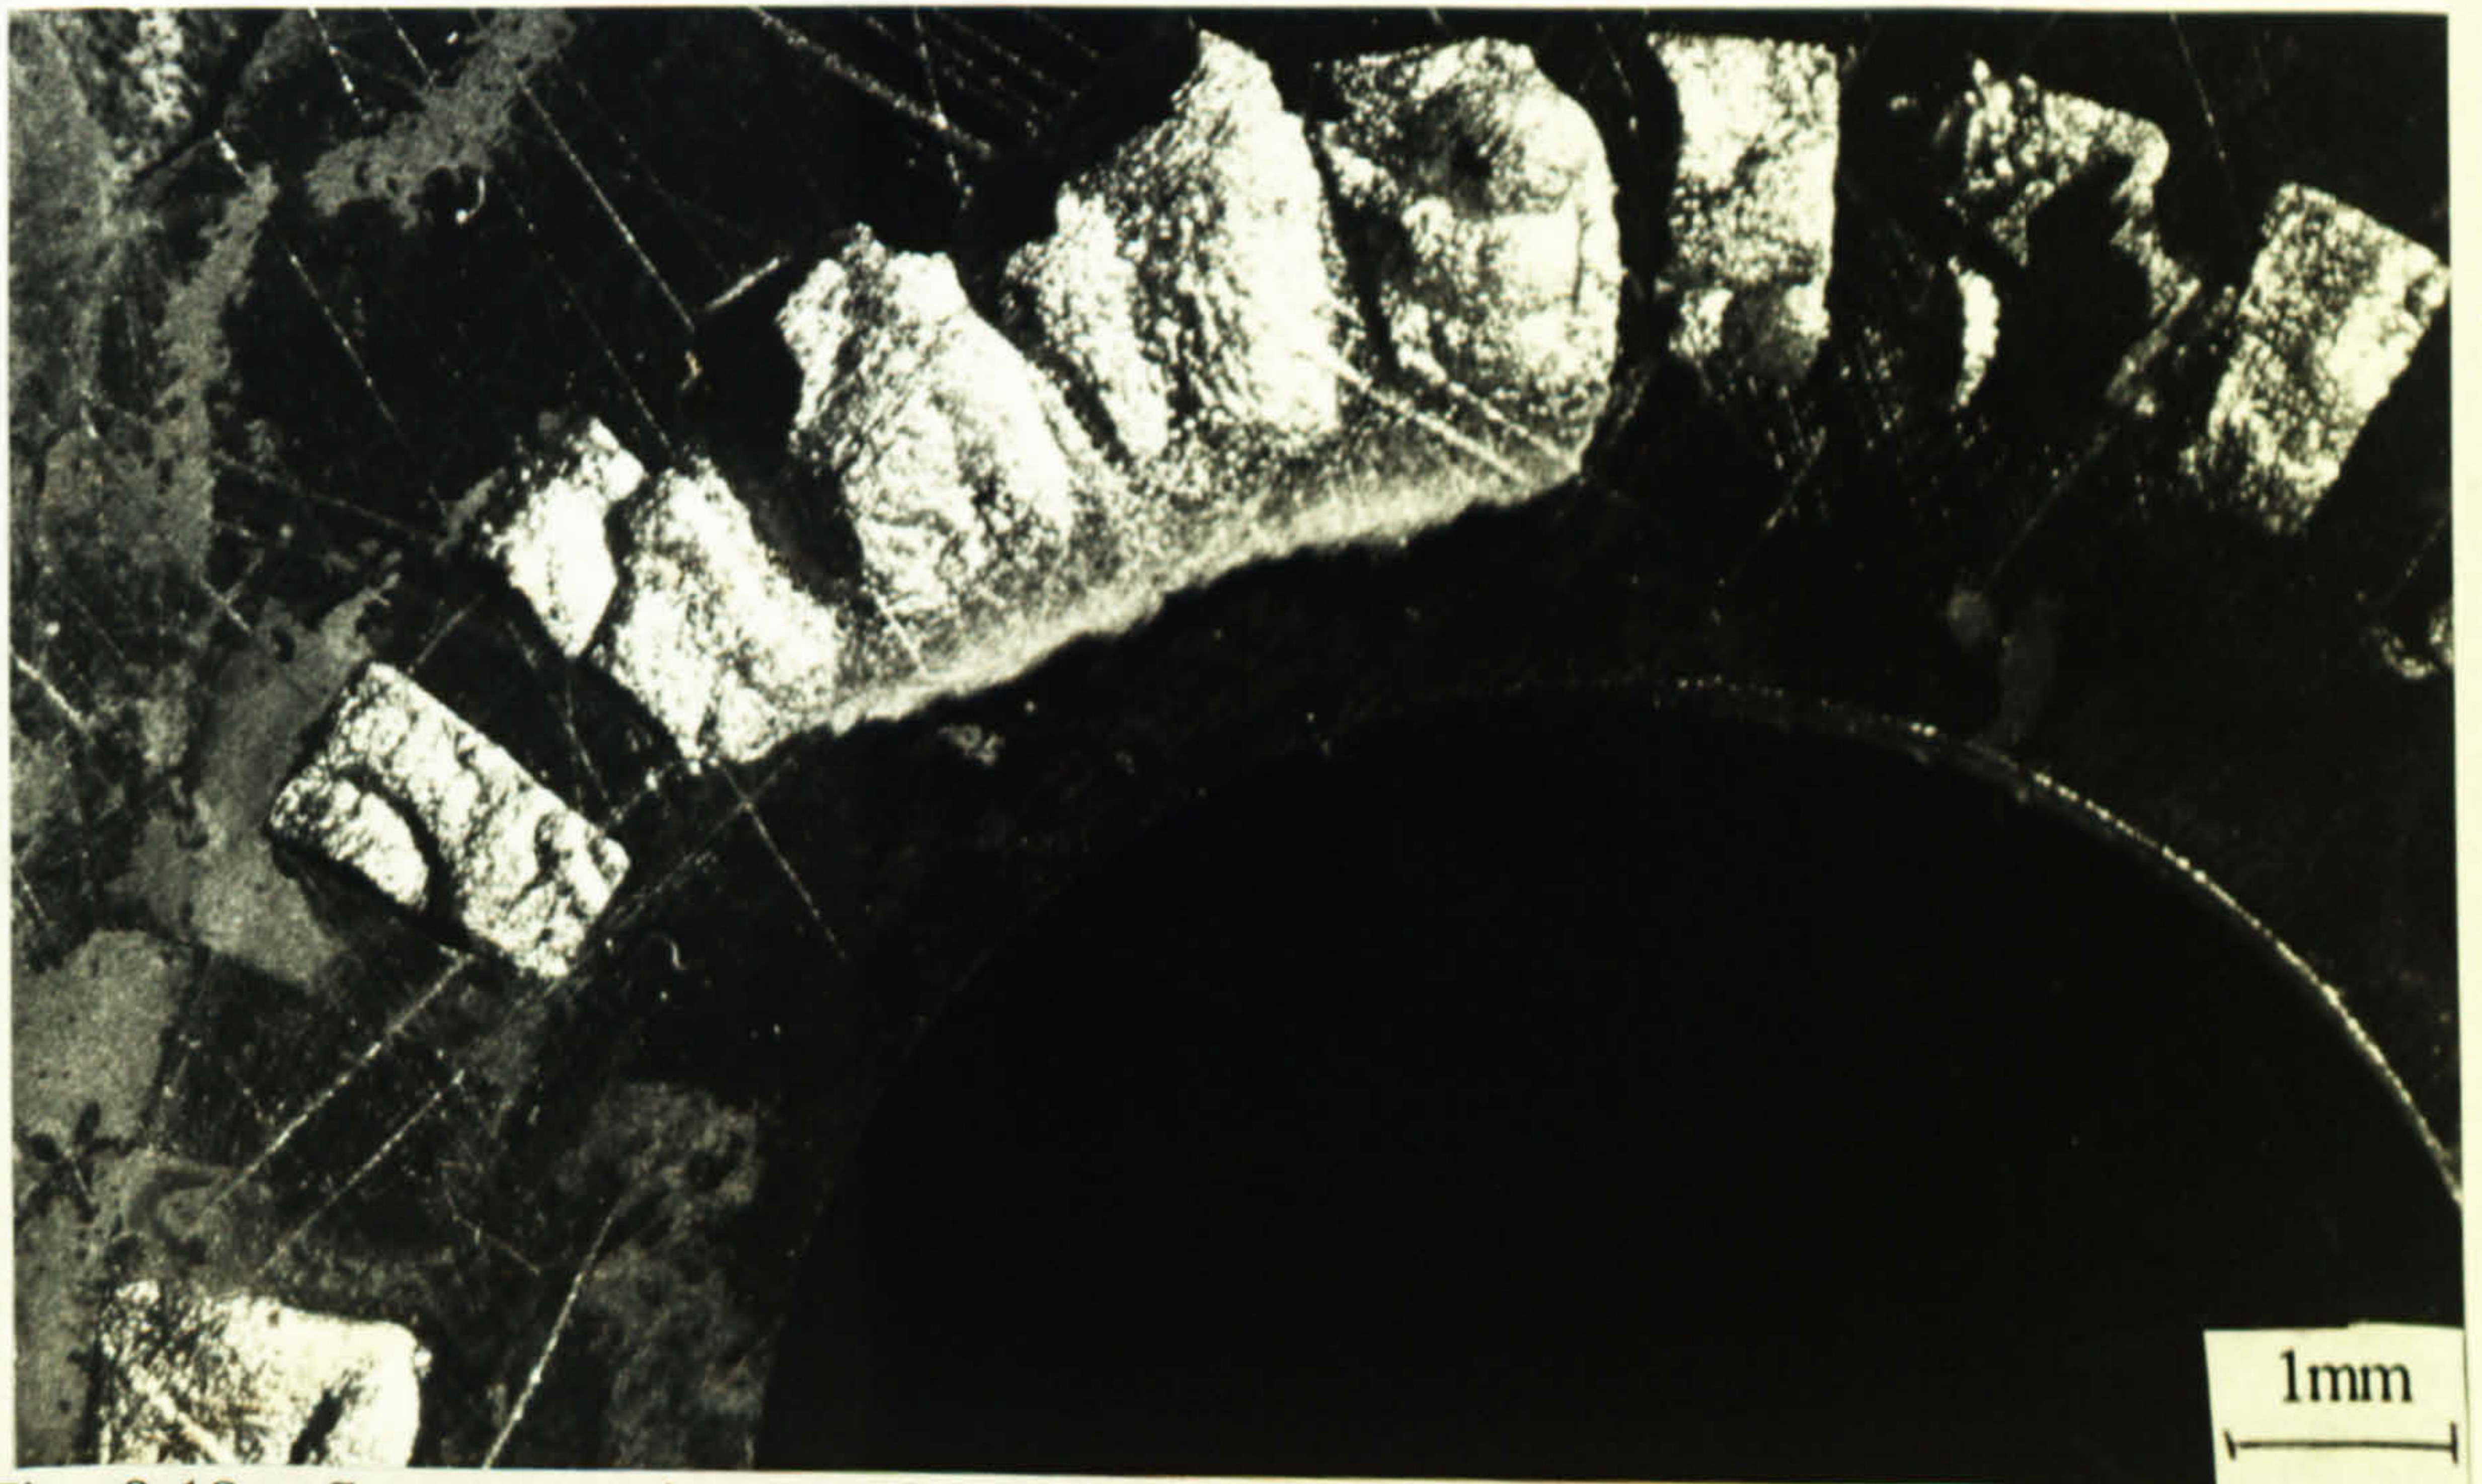
Fig. 9.18a. Severe crevice attack at every groove at the crevice assembly on UNS S31603 after 35 days in static conditions (a) view of overall assembly (b) attacked region
